Reference: Cove Pond and Dam Study  
Stamford and Darien, Connecticut

# STUDY OF COVE POND AND DAM STAMFORD – DARIEN, CONNECTICUT

Frederic R. Harris, Inc.  
Stamford, Connecticut  
November, 1973  
04-406-01

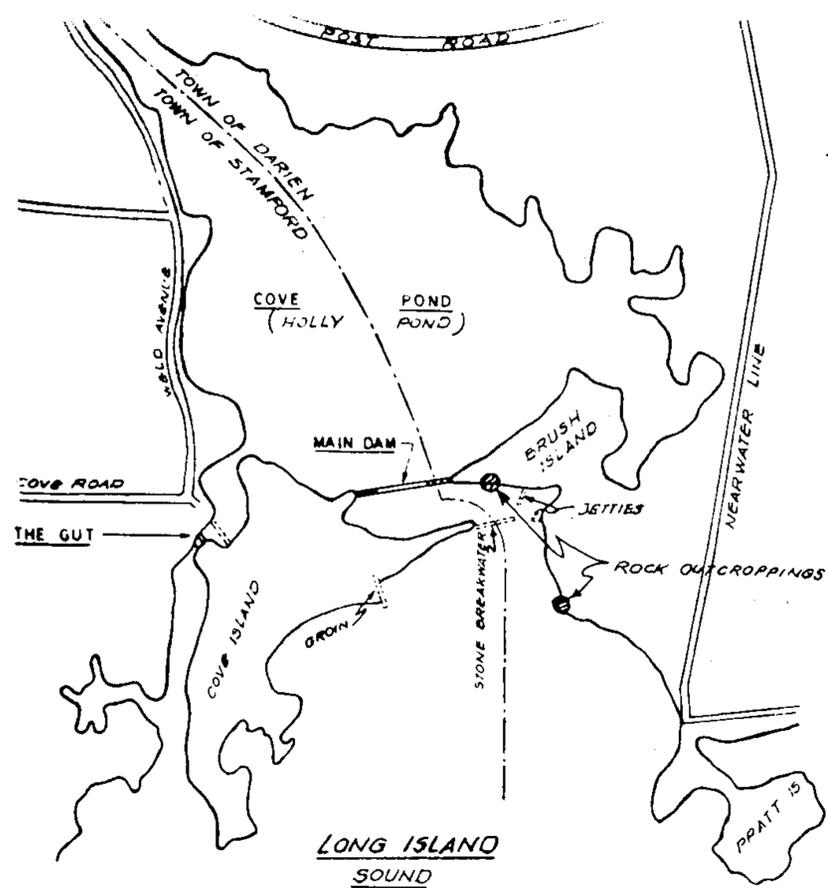
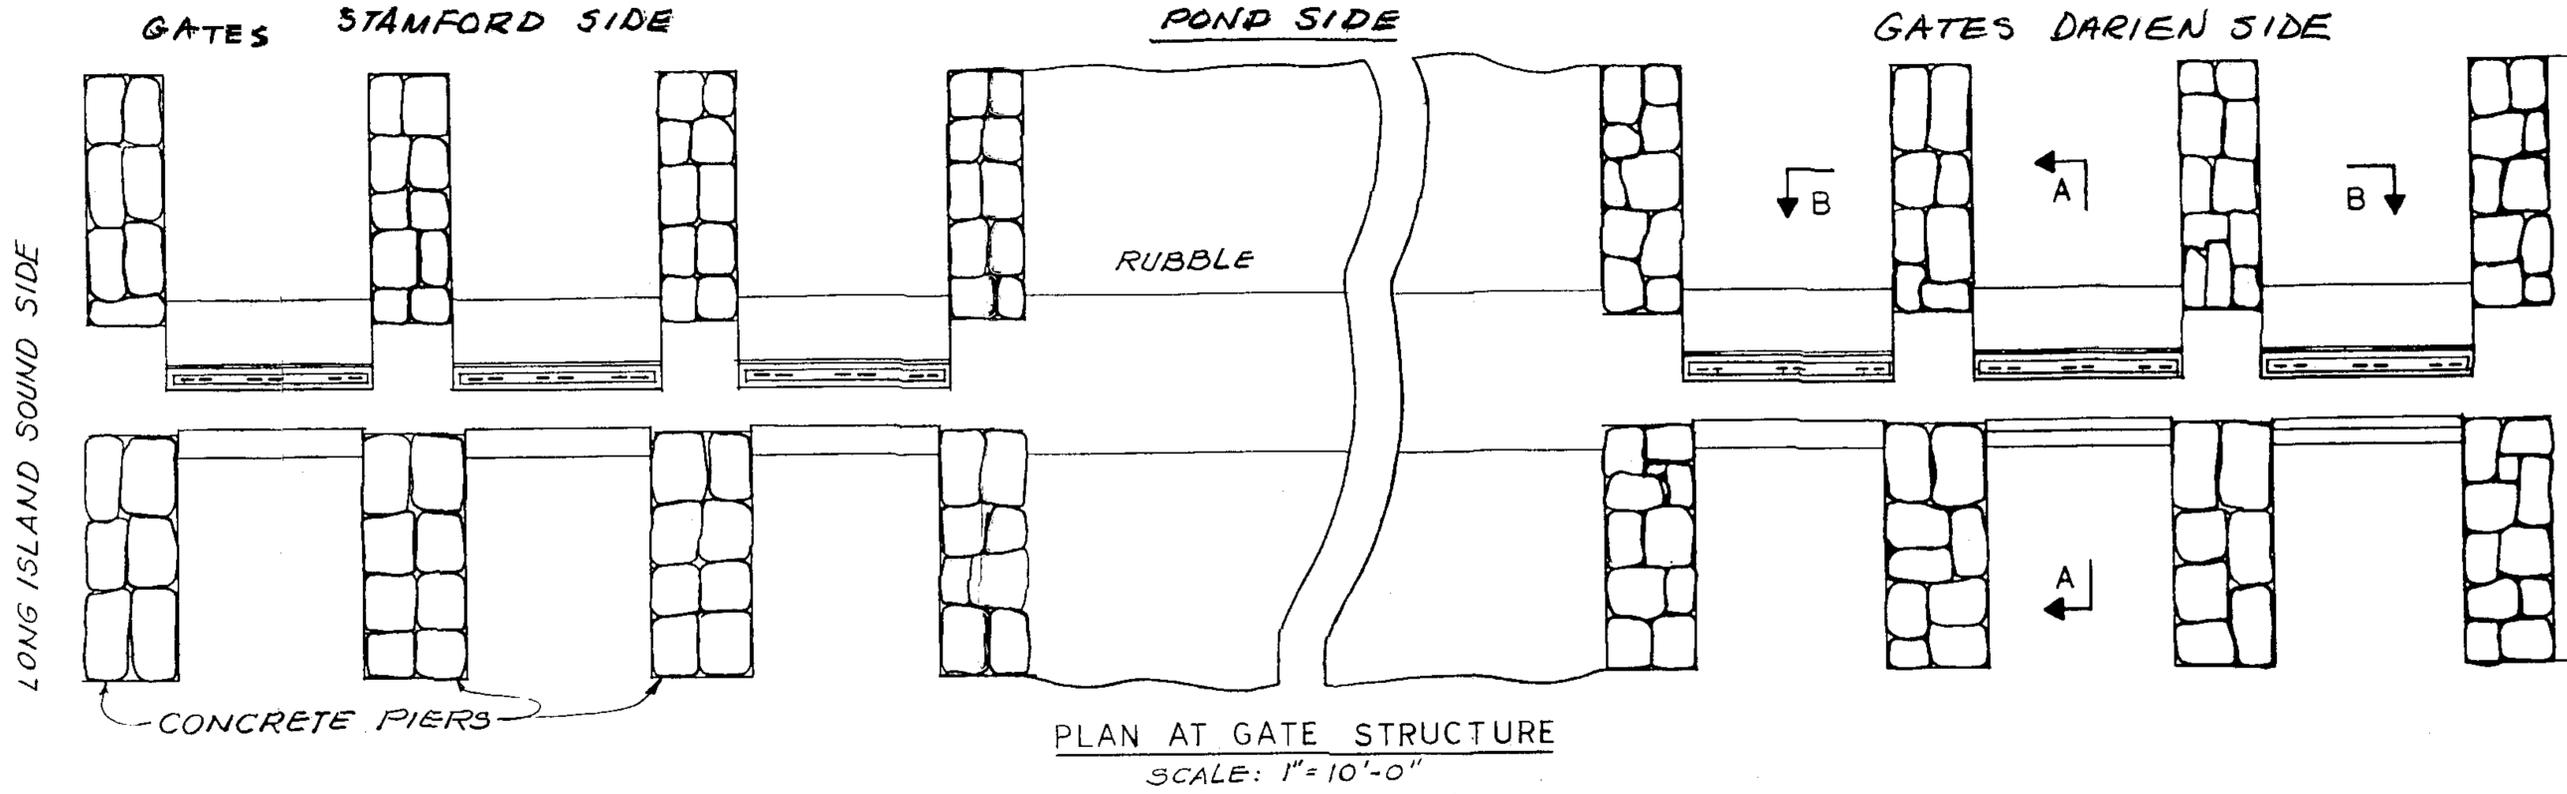
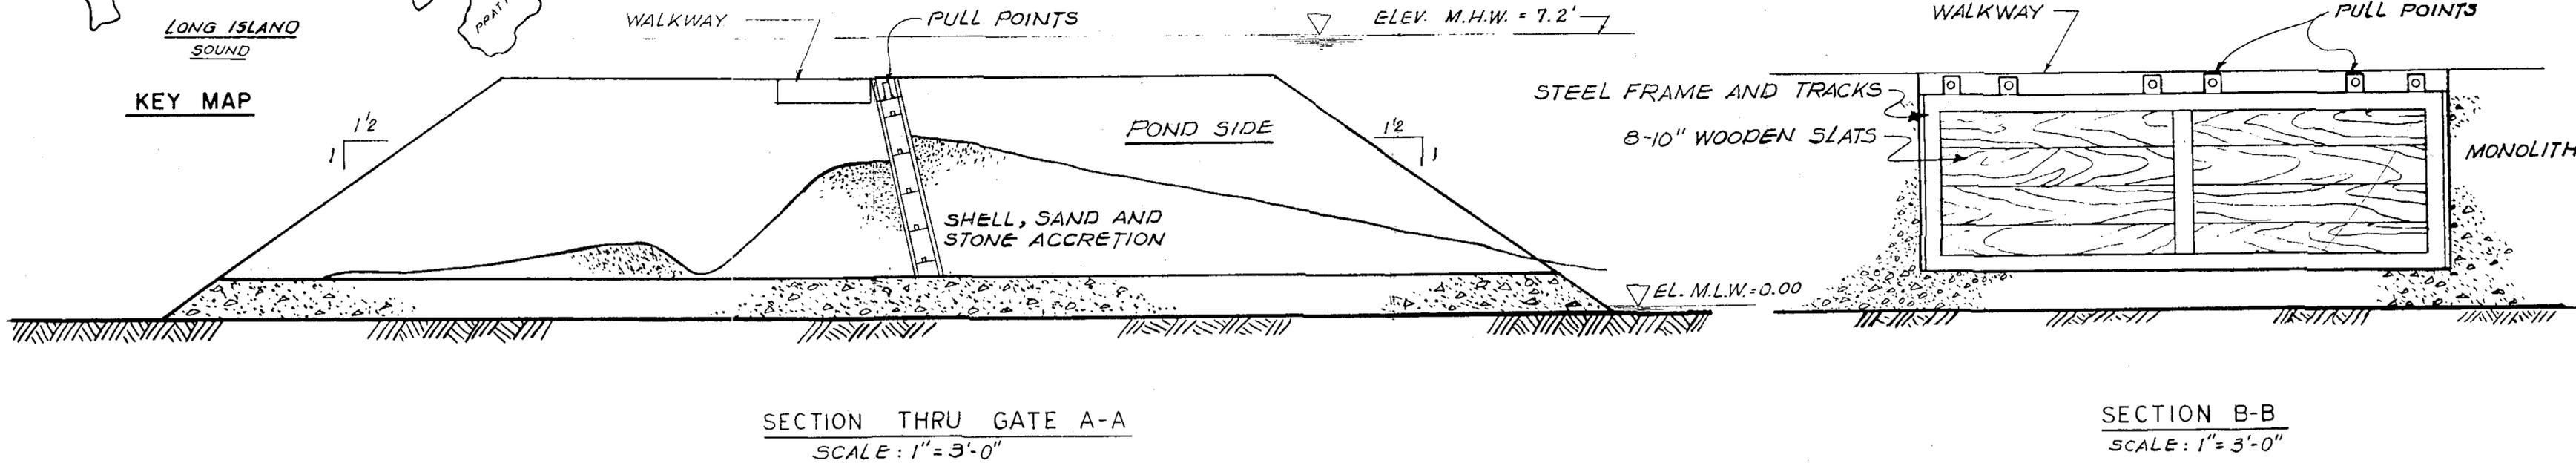
FIGURE No. 6

The inspection indicated that the overall condition of the gates and the concrete monoliths used to house the gate systems was generally good. A sketch of the dam, gates, and gate housing may be seen in Figure 6.

A large accumulation of sand, stones and shell was noted in the sluiceways of the individual gates. Evidently, this material is reasonably soft and loose in nature. It was the opinion of the divers that it would not prove difficult to remove.

Based on the underwater inspection, no visible signs of deterioration on the back side of the dam or the associated gates and housings were noted. It was concluded that the condition of the gates and concrete monoliths would allow removal of the gates if this was deemed desirable.

DIVER'S SKETCH - COVE POND DAM AND ASSOCIATED GATES

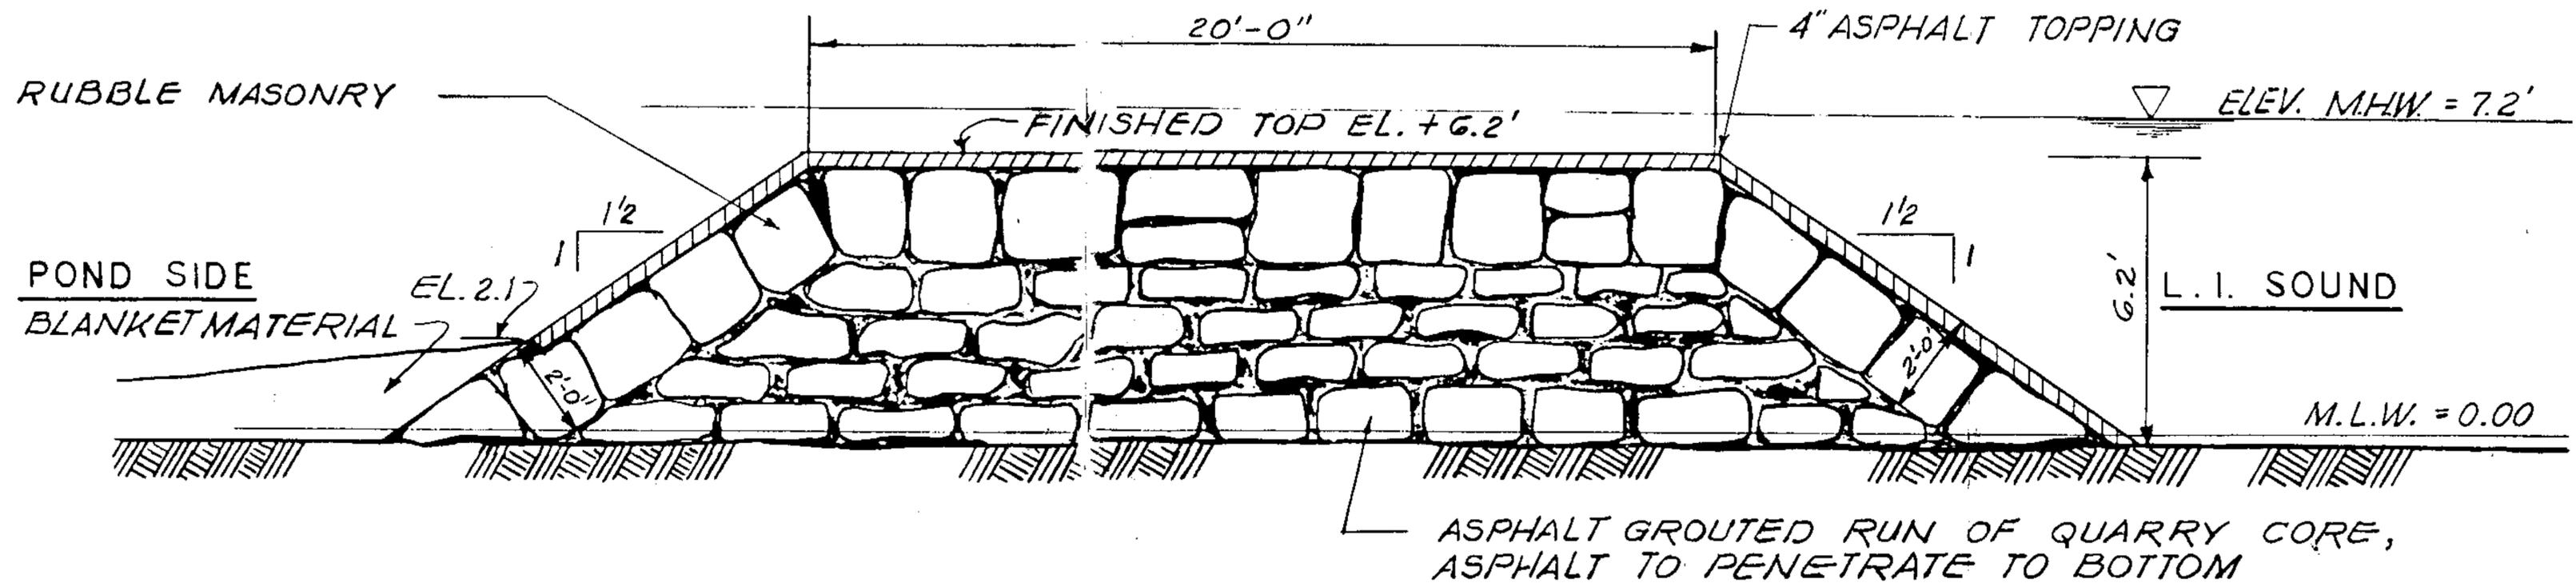
FIGURE No. 7

In order to further evaluate the condition of the dam and associated gates, a survey of the structure was undertaken on April 12th and 16th, 1973. This data was supplemented by underwater inspections previously described. Comparison of the results of this survey with original engineering drawings prepared by John J. Baffa and Associates in 1960 was undertaken. A section of the original dam, as designed, can be seen in Figure No. 7.

TYPICAL DESIGN CROSS-SECTION  
COVE POND DAM

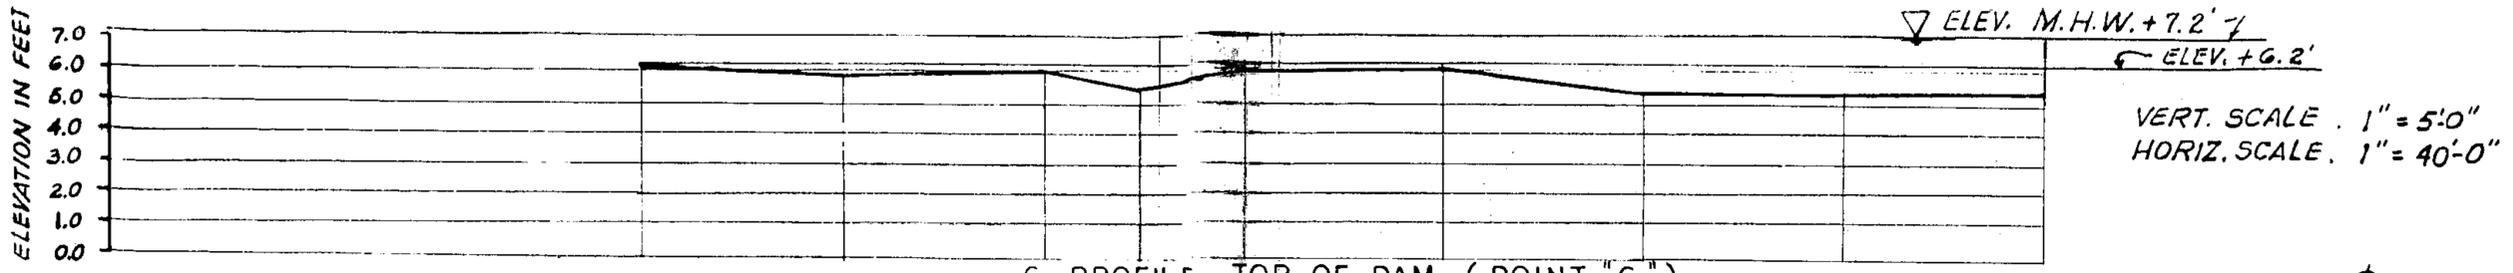
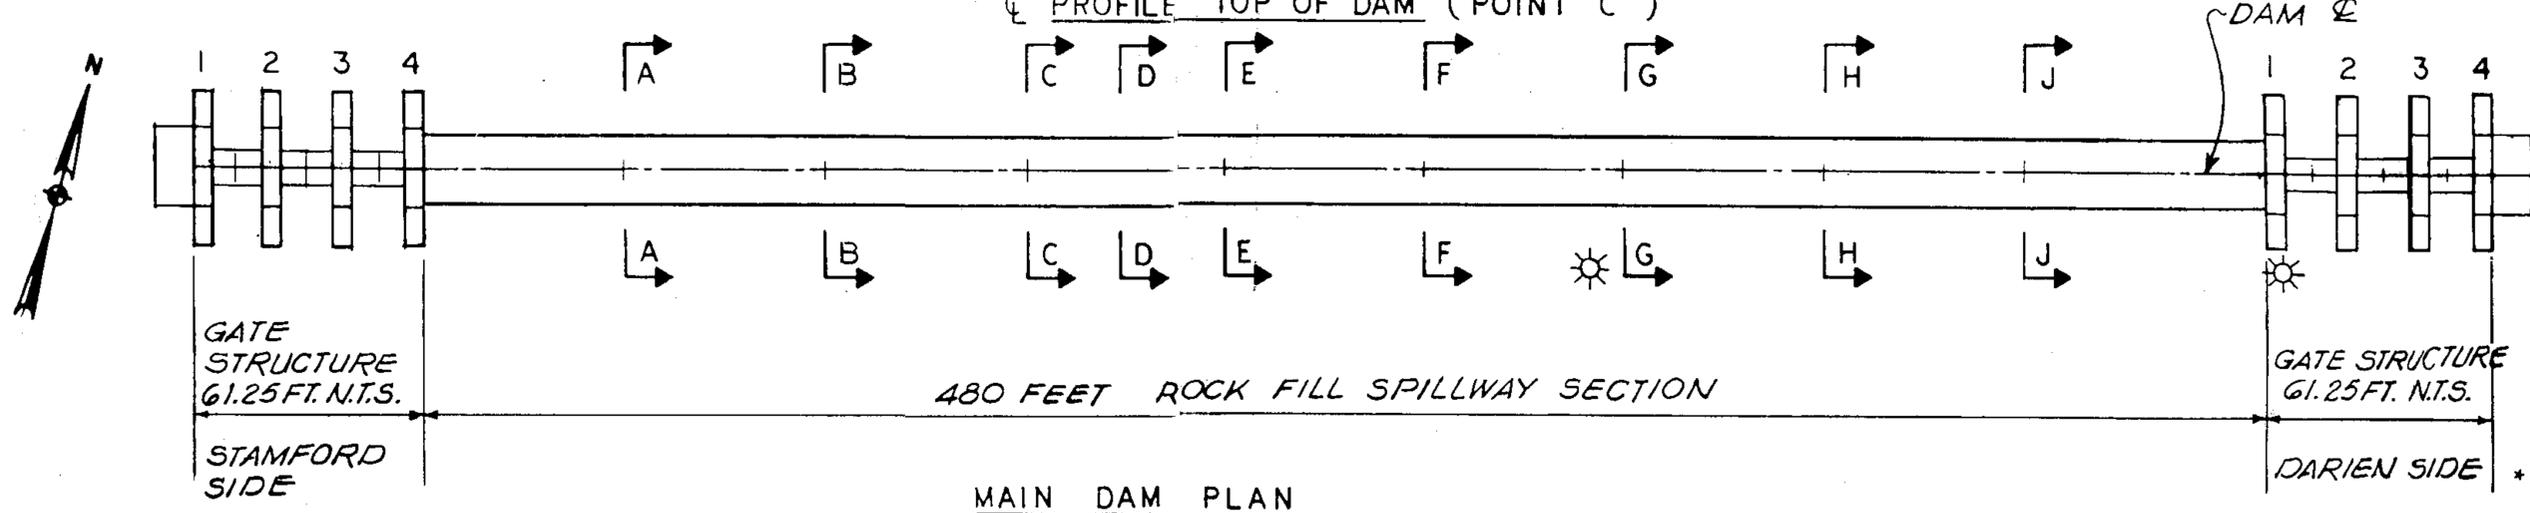
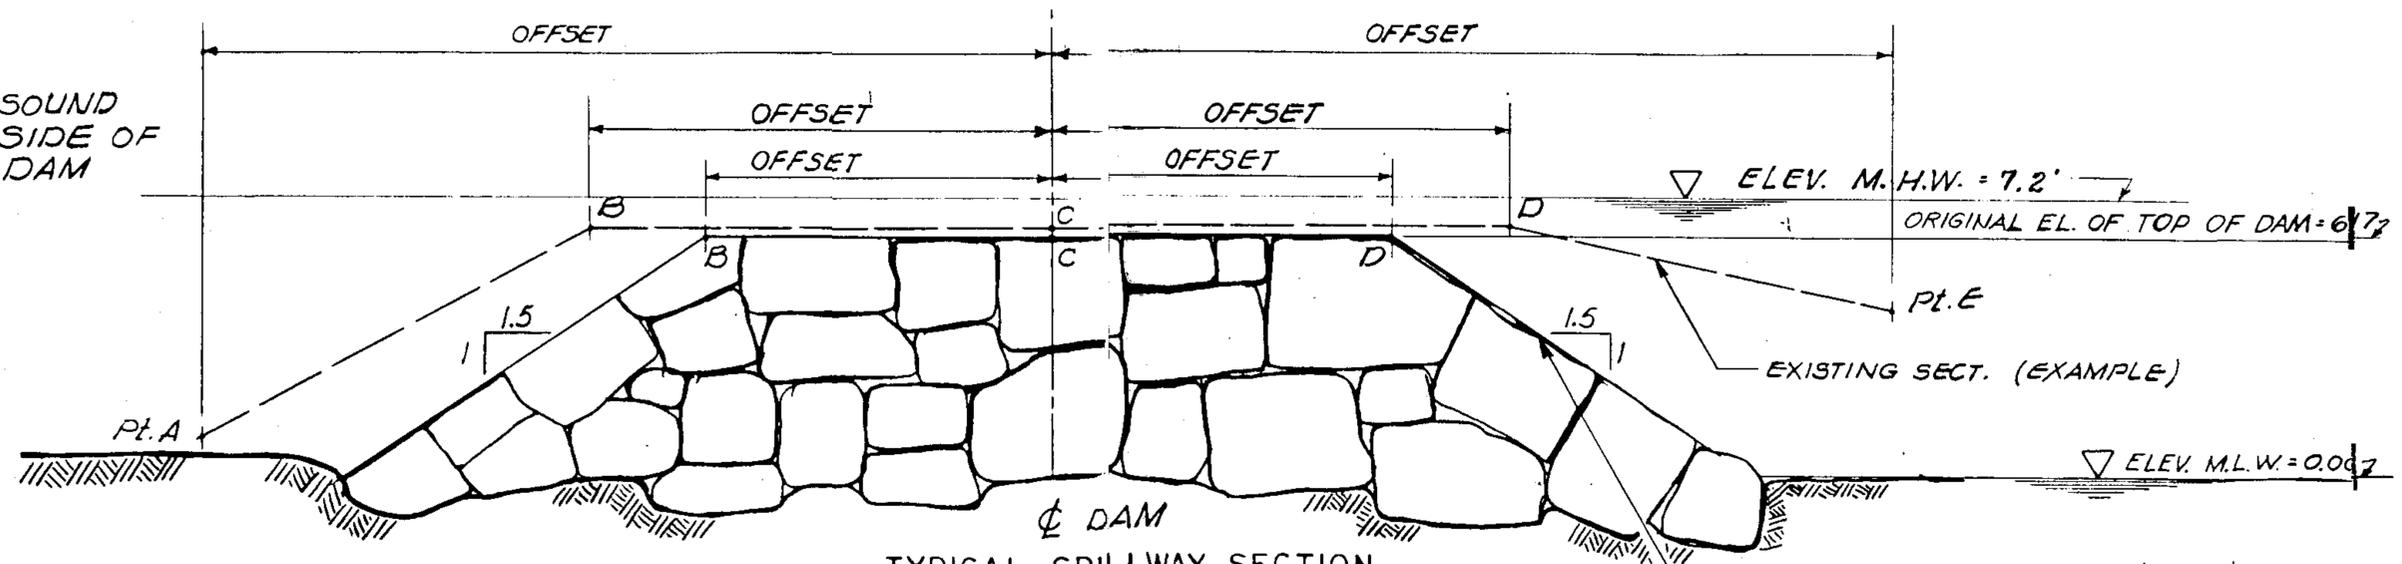
FIGURE No. 8

This data indicates that a settling or, more probably, a slumping of the structure has occurred on the Darien side of the rubble mound. Flow over the structure was also noted at these points. Little or no settling of the concrete monoliths used to house the gates has occurred. Elevations of the gate housings can be seen on Figure 9. The 1960 Cove Pond Dam construction drawing indicated a four inch asphalt topping mix was to be placed on the top of the dam. There was no evidence that this layer was ever placed.

Upwelling, or boiling, occurred at one point on the Darien side inside the gate housing. Another point of minor upwelling was found just off the center of dam nearer the Stamford side. The causes are not known. The locations of these points can be found on Figure 8.

It is also recommended that repairs be made along the surface of the dam, replacing stones to conform to the original design of the dam. It is estimated that the order of magnitude of cost to make the repairs to the dam and to clean and to make operable the tidal gates is approximately \$20,000.
