Reference: Cove Pond and Dam Study  
Stamford and Darien, Connecticut

# STUDY OF COVE POND AND DAM STAMFORD – DARIEN, CONNECTICUT

Frederic R. Harris, Inc.  
Stamford, Connecticut  
November, 1973  
04-406-01

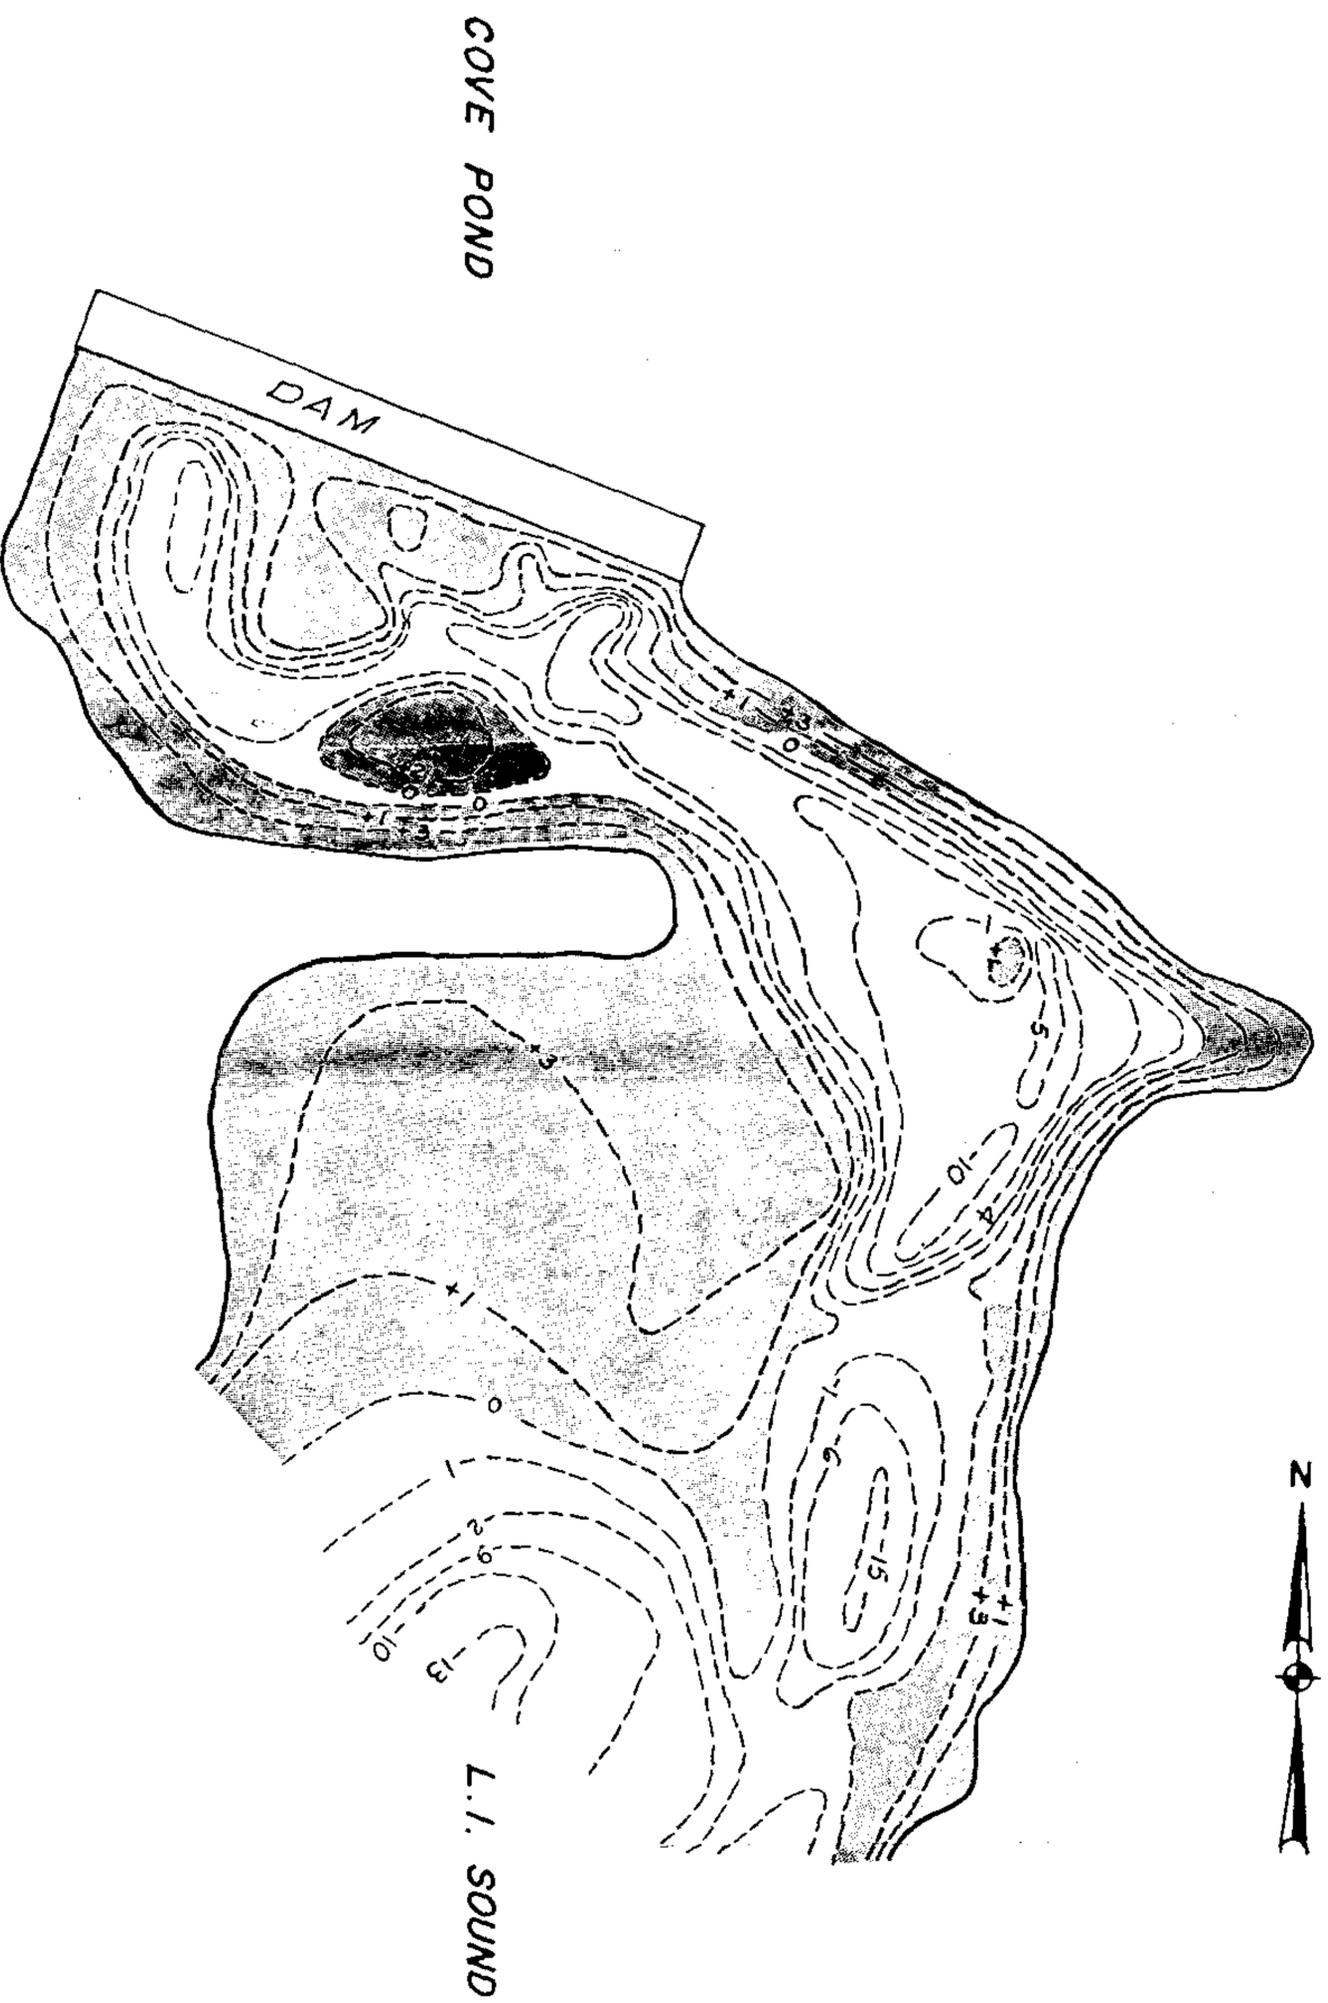
FIGURE. No. 5

Examination of this map of the inlet reveals the presence of two main flow channels running from points located approximately in front of the two sets of tidal gates out into the sound. Large shoal areas indicated by the shaded areas in Figure 5 have increased significantly the effective length of the inlet and generally reduced its hydraulic efficiency. The inlet hydraulic efficiency and limits of the dam-weir must be evaluated, when sufficient tidal stage data is developed.

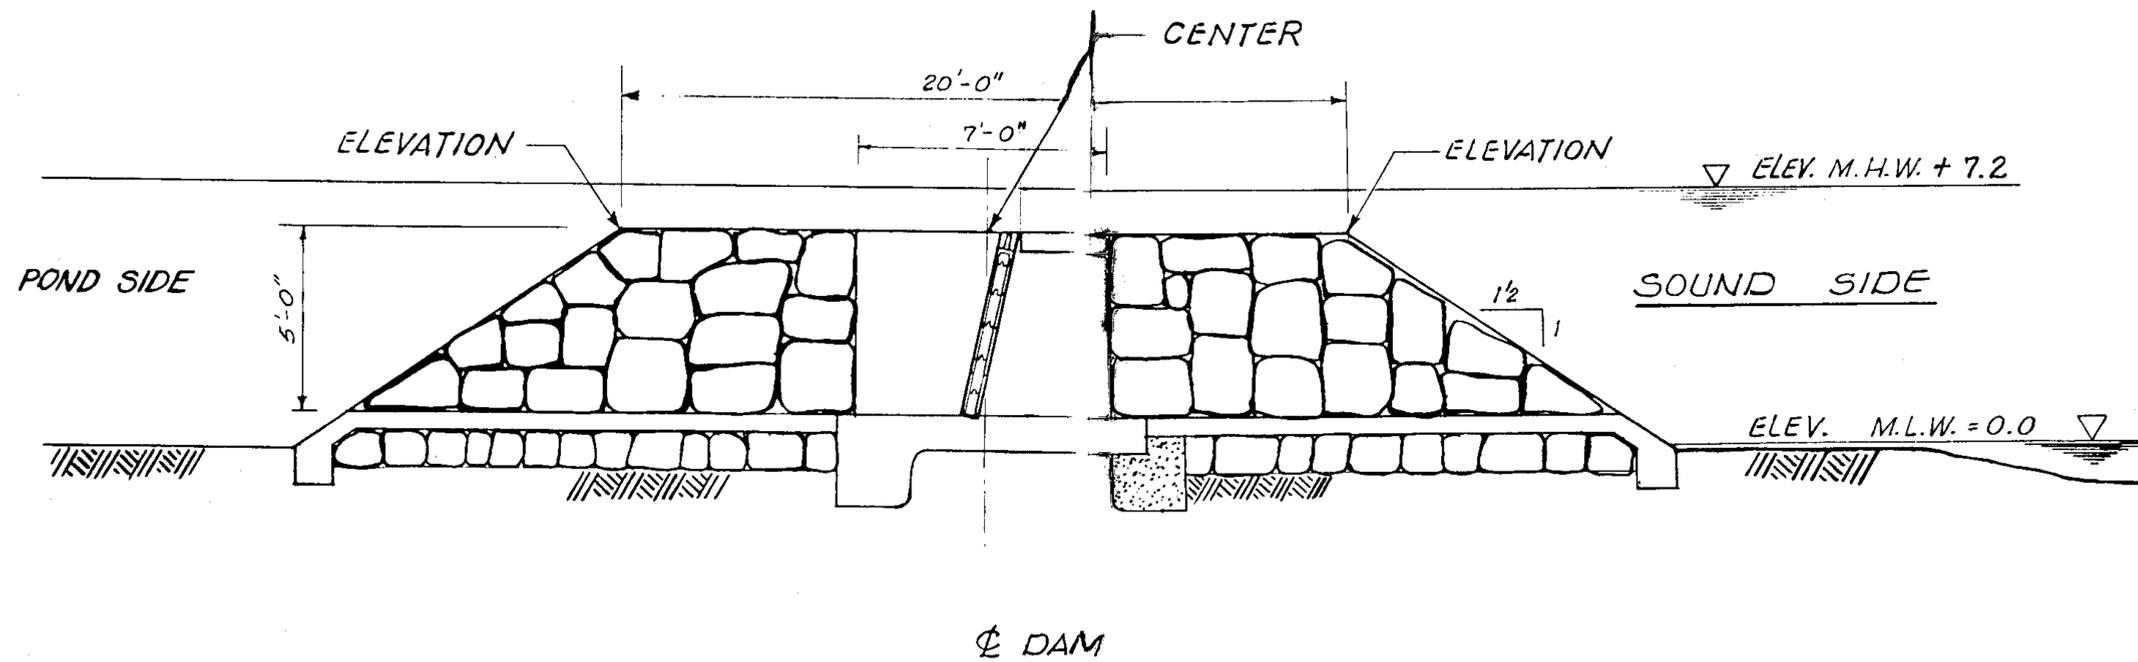
The inspection indicated that the overall condition of the gates and the concrete monoliths used to house the gate systems was generally good. A sketch of the dam, gates, and gate housing may be seen in Figure 6.

The gates are of guillotine construction with 8-10" wide wooden planks providing the body of the system. A steel frame fixes all the planks into a unit and is provided with six pull points to facilitate removal. A sketch is attached. Figure No. 6.
